# **OPERATIVE MONTHLY REPORT**

Unit: Cogeneration S1

## 5-964A-KA-01 - GAS TURBINE

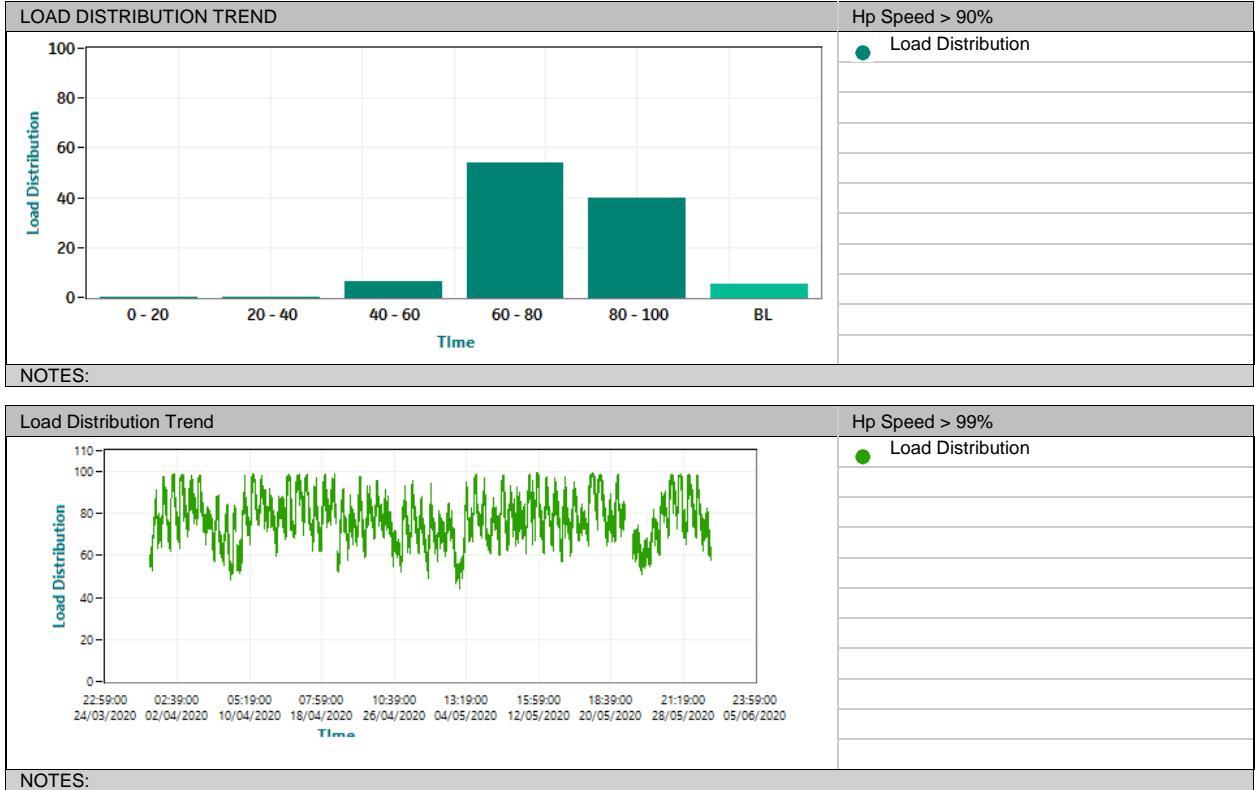
Figure 1 – Cogeneration S1 Load Distribution during report period

a)	Power	Following site needs, the unit was operated at medium-High range reaching baseload conditions for around 10% of time (see figure 1).
rmance	Heat rate	<ul> <li>In figure 5 and 6 are reported the high variability of Power and HR in function of Inlet temp and IGV angle.</li> <li>In baseload, the GT efficiency is around 30-31%</li> </ul>
Perfo	Combustion	Service request was opened for the events of flame out. RCA report shared with Customer
	Exhaust Section	Exhaust spread is constantly around 30 C in baseload conditions See figure 9 for the polar distribution
	Vibration	Low Values in amplitude for GT/GB/GEN seismic and GT radial vibrations, with the only anomaly due to spread between the two Seismic readings VE194 A and B

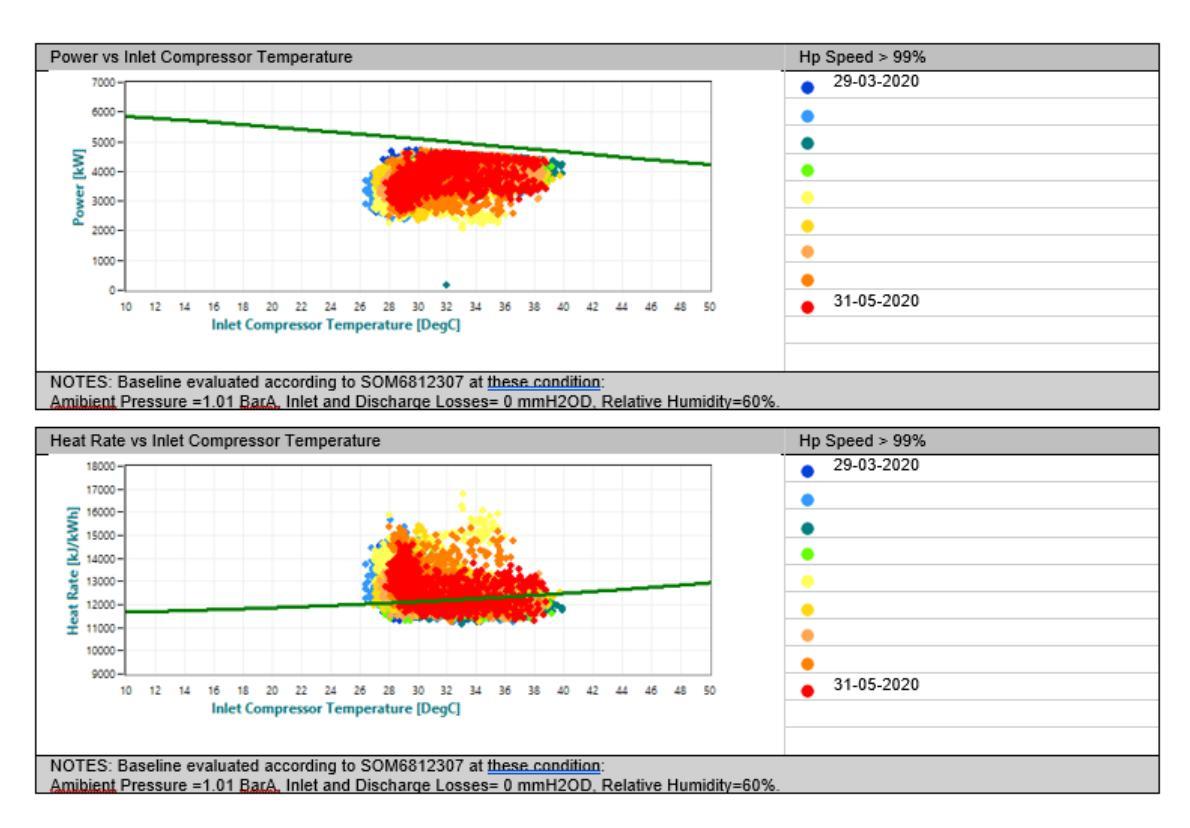
The following charts are reporting power and HR vs Inlet temperatures with expected curves based on the Standard S1 with the following conditions:

- Ambient Pressure =1.01 Bar
- Inlet and Discharge Losses= 0 mmH2OD,
- Relative Humidity=60%.

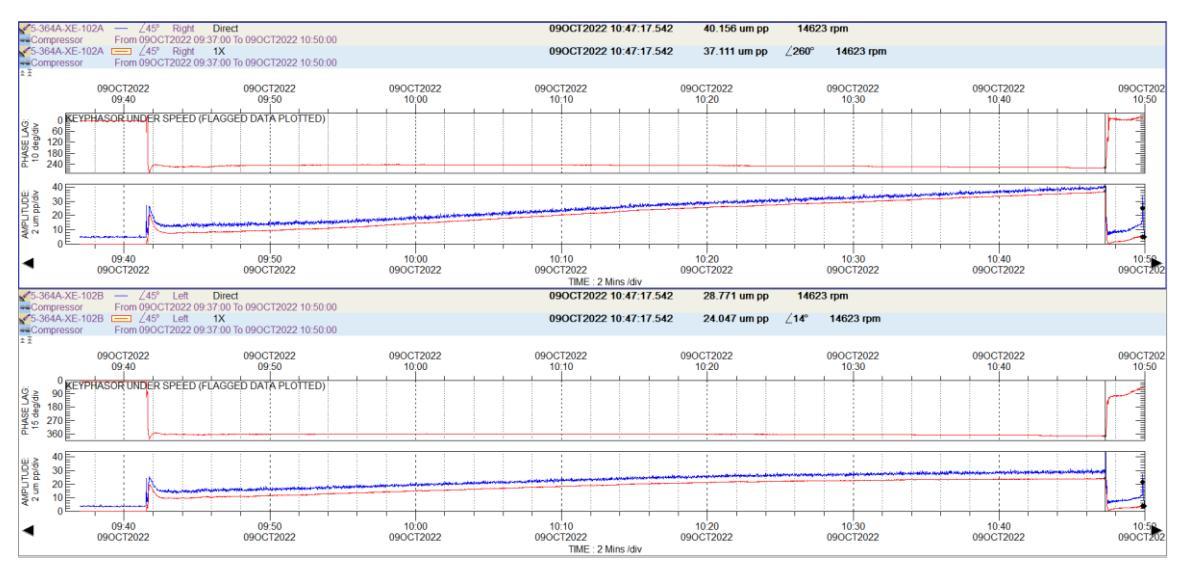
GAS TURBINE								
		1X						
Probe	Direct [µm]	[µm]	Phase [°]	Side [DE/NDE]				
XE-102A	40.1	37.1	260	DE				
XE-102B	28.8	24	14	DE				
XE-103A	14.6	5.9	181	NDE				
XE-103B	13.1	4.6	249	NDE

Figure 5 – DE side radial probe trend [µm pp]

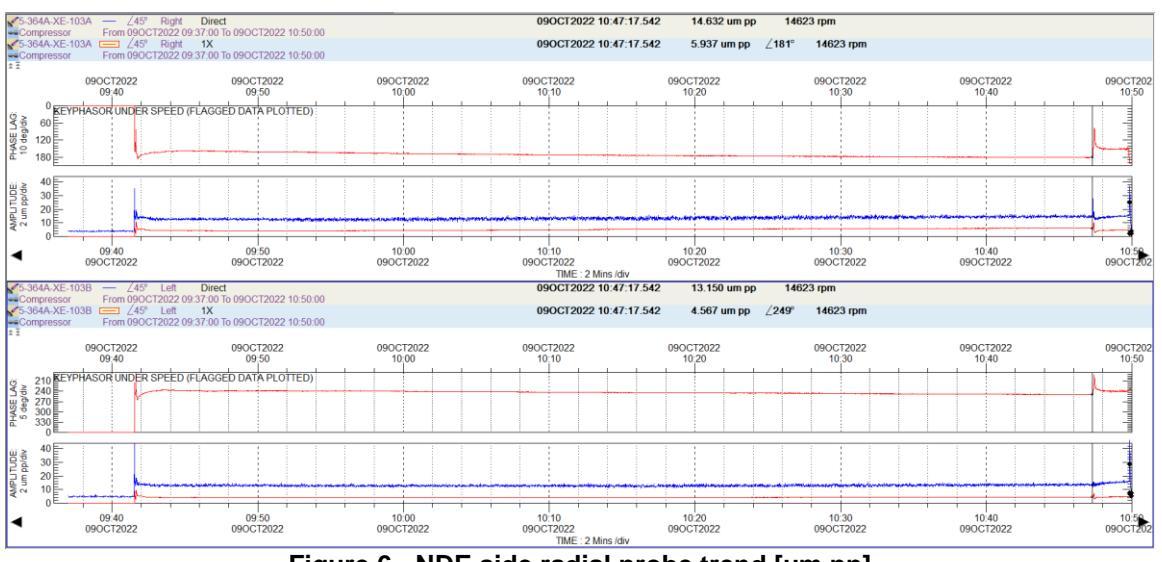
Figure 6 - NDE side radial probe trend [µm pp]
